TECHNICAL SERVICE BULLETIN

Re: NIU MQiGT Evo NHTSA Recall

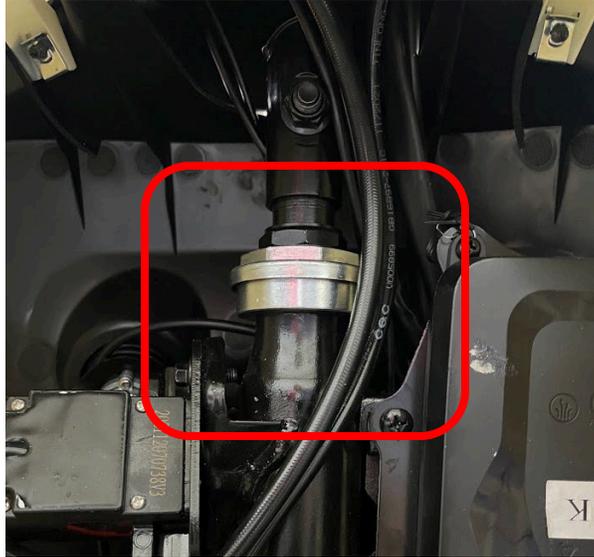
1. New steering bearing installation: head-on photo of the new steering collar and lock nut tightened to spec.

Remedies: To remedy the motor firmware issue, the motor will be replaced with a new motor with updated firmware. To remedy the handlebar vibration, tapered roller bearings will be installed replacing the steering stem ball bearings on EVO models. Both issues will be resolved at no charge to the consumer.

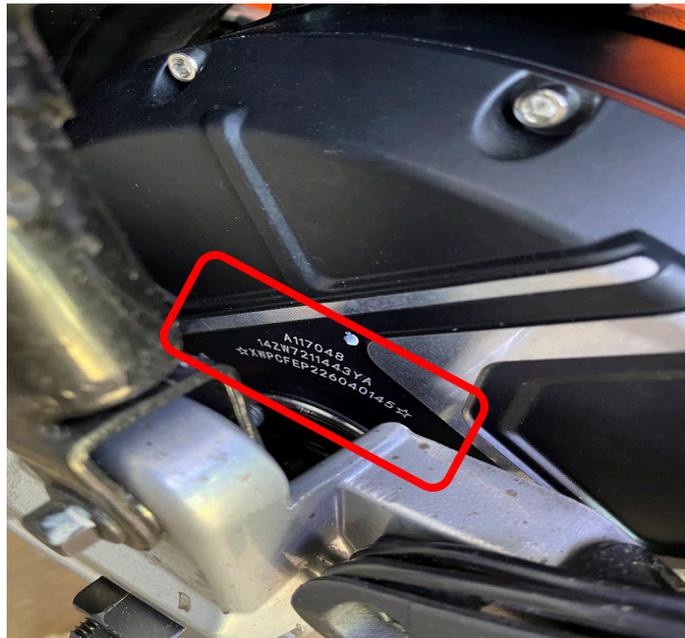
2. New motor installation: please be sure to include a photo of the motor serial number, which is bookended by stars, after installation.
