Service Bulletin

Energica Motor Company SpA

Subject:	DROP OF TRANSMISSION OIL LEVEL CHECK
Technical info n°:	22-SI-2723. DROP OF TRANSMISSION OIL LEVEL CHECK v.2
Issue Date:	July 04th, 2023
Models:	EXPERIA
VIN numbers:	VIN number list below
Group:	Maintenance
Type:	Bulletin
Supersedes:	22-SI-2723. DROP OF TRANSMISSION OIL LEVEL CHECK

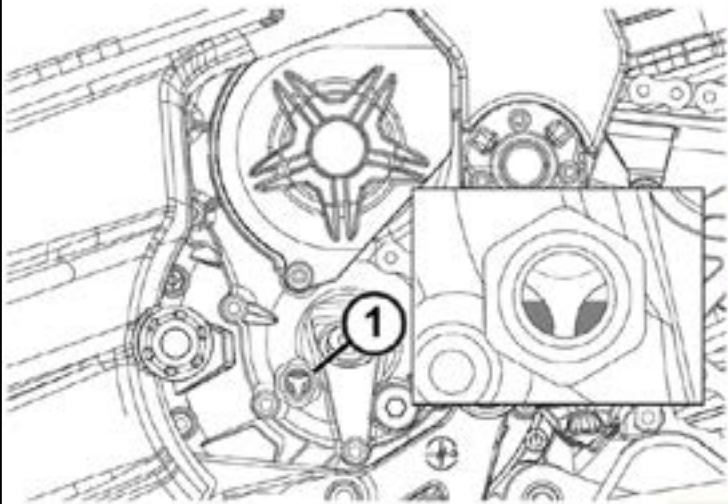
Figure 1

1.1.1 Check the transmission oil level through the inspection window on the left-hand side of the motor.

1.1.2 The level should be as shown in the illustration.

1.1.3 If the level is lower than the minimum mark, perform a top-up.

However, if the oil level does not meet the required specifications, it is required to top up the transmission oil to the correct level as described in chapter 2.11 of the service manual.

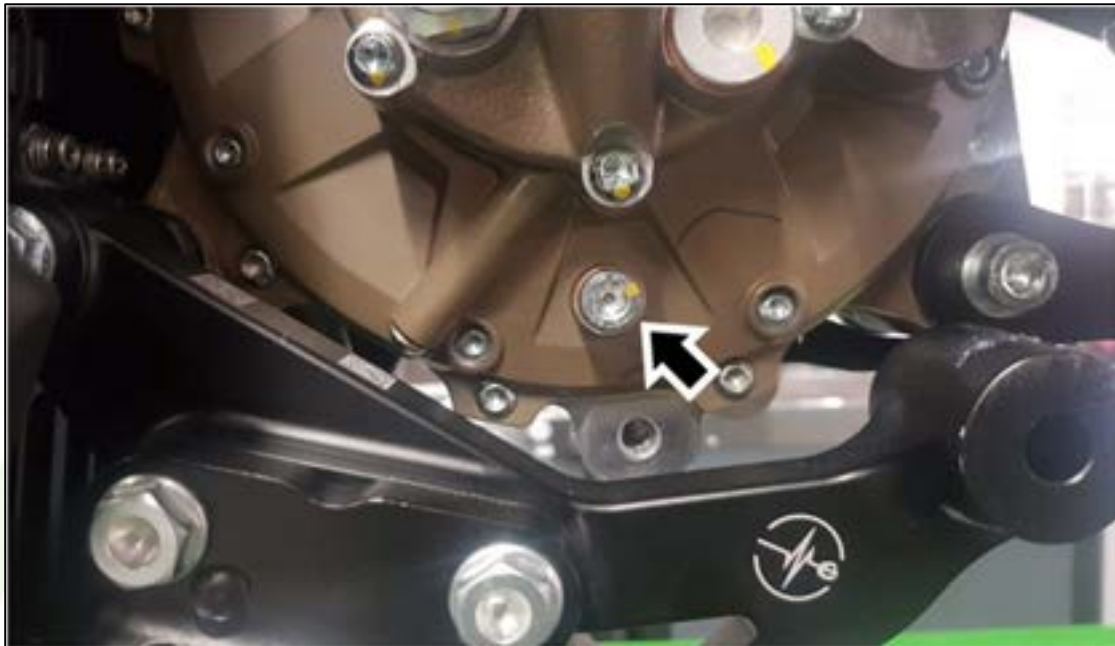
Figure 4

Within this section of the motor, verify the presence of oil traces by inserting a cable tie. If oil is found in this area, report it to Energica Motor Company.

In case oil traces are found as described in point 5 (figure 4), we kindly request you to report it to Energica Motor Company.

- 5- (Figure 4) - rotate the kickstand support as shown in order to access and remove the indicated screw.
